## CASE STUDY SEAWALL REPAIR

### Treasure Island Marina Seawall Stabilization

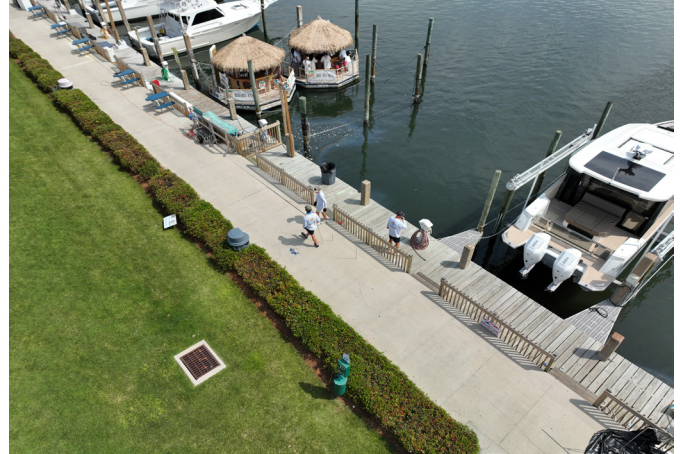
Inspections revealed minor deflection in the seawall panels, which were structurally sound overall. However, soil probing identified significant voids and eroded areas behind the wall. A previous repair attempt using concrete pressure grouting had worsened the issue; cementitious material added excessive weight to the seawall and adhered to the underside of sidewalk sections, exacerbating settlement. The primary challenges included large voids beneath the sidewalk and ongoing hydrostatic pressure imbalances.

The repair plan combined three strategies to address both immediate and long-term concerns. First, SW-RP1, a single-component polyurethane grout, was injected to seal the base of the seawall panels, bonding remaining soil to the structure and preventing future erosion. Second, AP Lift 430, a two-component structural polyurethane foam, was injected to fill large voids under the sidewalk and gently re-level the settled sections. Finally, permeable pressure control filters were installed in the middle of each panel to equalize hydrostatic pressure, reducing soil migration.
